**DEPARTMENT OF TRANSPORTATION**

Contract #: 04-0120F4Cty: SF/ALA Rte: 80 PM: 13.2/13.9File #: 69.28**WELDING INSPECTION REPORT****Resident Engineer:**Siegenthaler, Peter**Address:** 333 Burma Road**City:** Oakland, CA 94607**Report No:** WIR-024332**Date Inspected:** 11-Jun-2011**Project Name:** SAS Superstructure**OSM Arrival Time:** 700**Prime Contractor:** American Bridge/Fluor Enterprises, a JV**OSM Departure Time:** 1900**Contractor:** Zhenhua Port Machinery Company, Ltd (ZPMC), Changxing Island **Location:** Shanghai, China**CWI Name:** Li Yang**CWI Present:** Yes No**Inspected CWI report:** Yes No N/A**Rod Oven in Use:** Yes No N/A**Electrode to specification:** Yes No N/A**Weld Procedures Followed:** Yes No N/A**Qualified Welders:** Yes No N/A**Verified Joint Fit-up:** Yes No N/A**Approved Drawings:** Yes No N/A**Approved WPS:** Yes No N/A**Delayed / Cancelled:** Yes No N/A**Bridge No:** 34-0006**Component:** OBG Trial Assembly**Summary of Items Observed:**

Orthotropic Box Girder (OBG) at Trial Assembly Areas

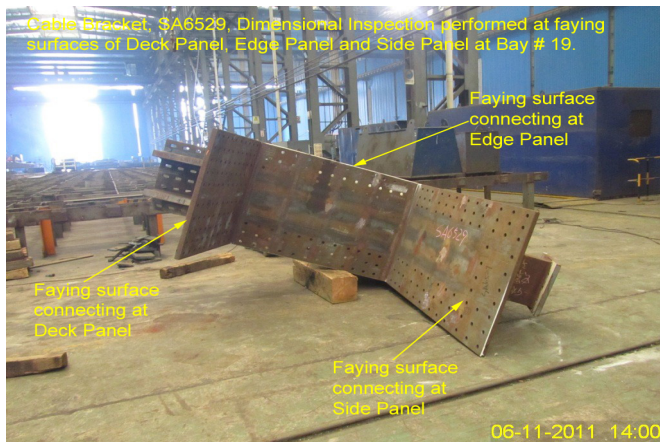
This QA Inspector performed Dimension Control Inspection to check and measure the flatness at Cable Brackets Plates connecting Deck Panel, Edge Panel and Side Panel. The following Cable Brackets were inspected and observed flatness within the allowable tolerances.

SA6529

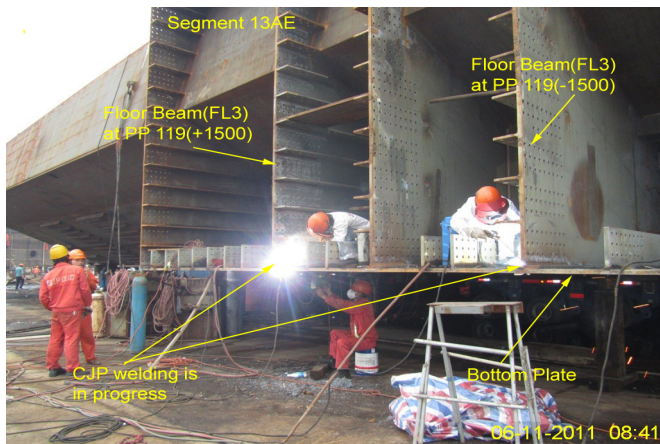
This QA Inspector observed the in-process welding by Shielded Metal Arc Welding (SMAW) process on a Complete Joint Penetration (CJP) weld. The weld joint was designated as FB3125-001-178. The welder identification was 054467 and observed welding in the 2G (Horizontal) position using approved Welding Procedure Specification WPS-B-P-2212-Tc-U4b-FCM-1. The piece mark was identified as weld connecting the Floor Beam FL3 to the Bottom Plate Flange at PP 119(-1500).

This QA Inspector observed the in-process welding by Shielded Metal Arc Welding (SMAW) process on a Complete Joint Penetration (CJP) weld. The weld joint was designated as FB3122-001-188. The welder identification was 215248 and observed welding in the 2G (Horizontal) position using approved Welding Procedure Specification WPS-B-P-2212-Tc-U4b-FCM-1. The piece mark was identified as weld connecting the Floor Beam FL3 to the Bottom Plate Flange at PP 119(+1500).
